The show must go on

After a heritage-sensitive refurb, the leading lady of Hastings is ready to be in the limelight once again.

Recently rebranded as part of the Toitoto – Hawke's Bay Arts & Events Centre, the building remains an exceptionally significant specimen of New Zealand's heritage, one of its last surviving theatres designed by renowned theatre architect Henry Eli White.

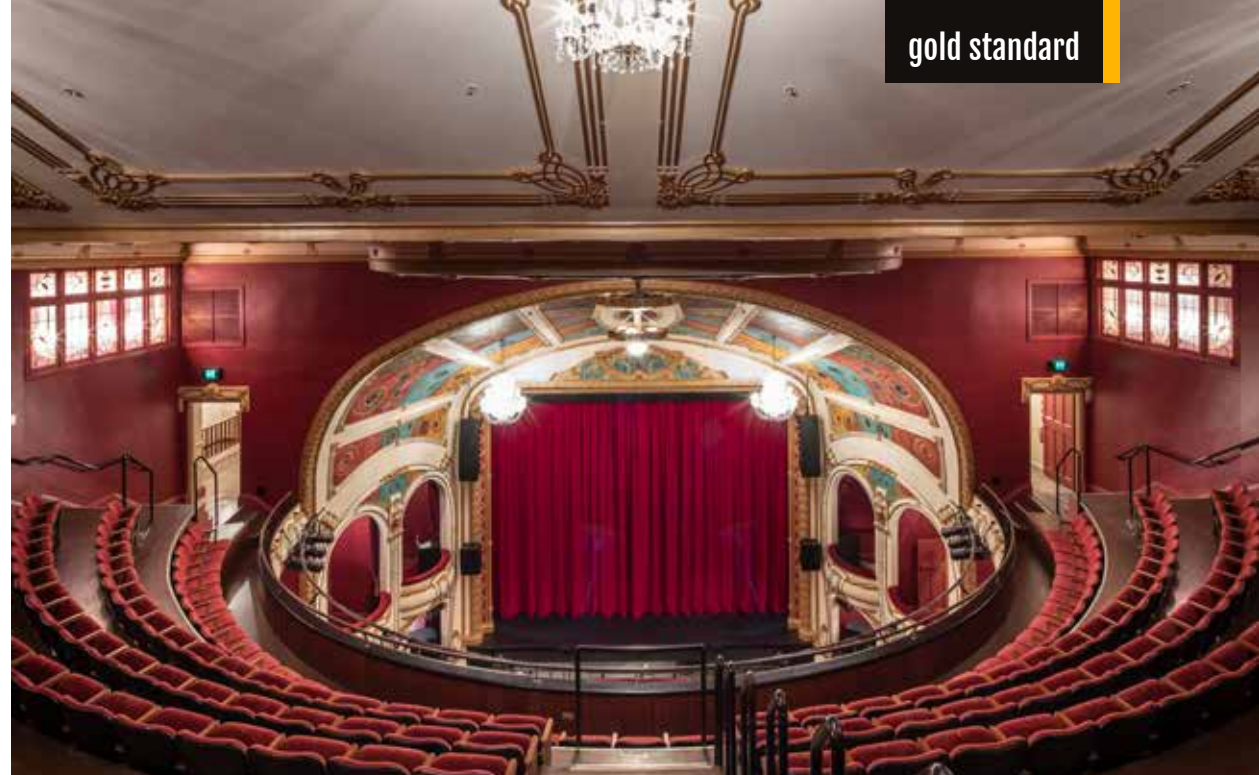
opposite: Heritage New Zealand has described the opera house as one of the earliest buildings designed in the country using the Spanish Mission style, with its lavish Art Nouveau interior suggested to be the largest and most complete example of its type in New Zealand.

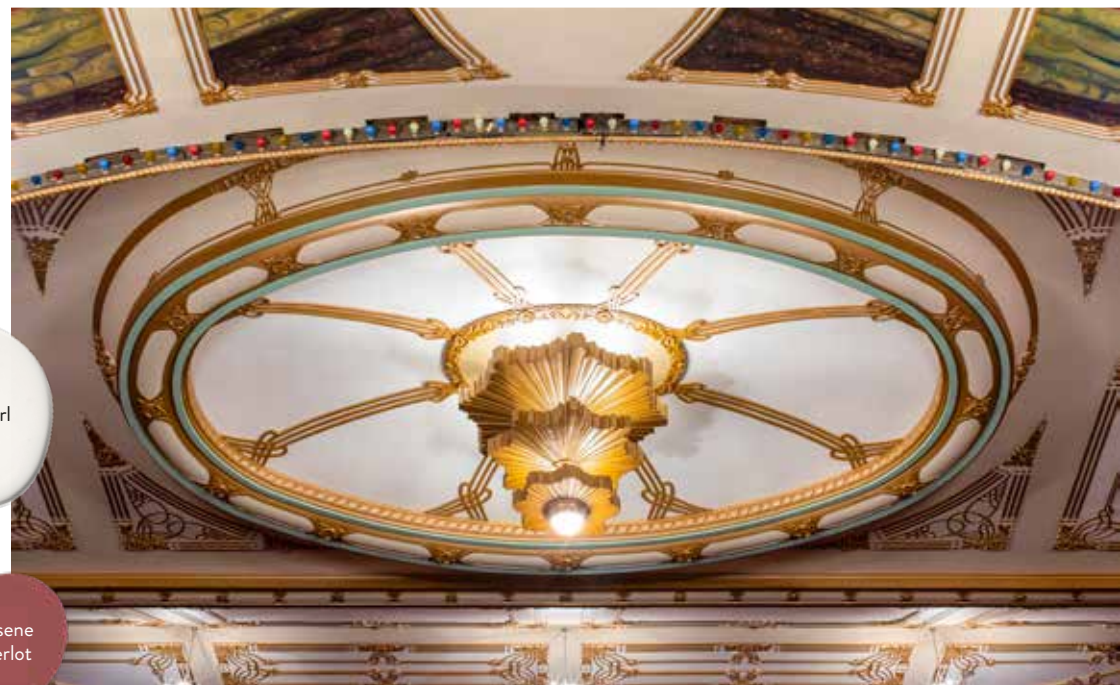
above right: Walls in Resene Vanquish suit the drama and grandeur of the auditorium and tie in with the rich burgundy textiles used for the curtain and seats. Windows and doors in Resene Lustacryl semi-gloss waterborne enamel tinted to Resene Merlot, ceilings and balconies in Resene SpaceCote Low Sheen waterborne enamel tinted to Resene Half Pearl Lusta, Resene Eighth Pearl Lusta and Resene Triple Pearl Lusta and select details in Resene Lustacryl tinted to Resene Gum Leaf.

below right: According to artist Tina Carter, the detailing of her Art Nouveau-style motifs represented the four colours and themes of the opera house: community, dance, music and drama. While the intention was to retain the mural within the oval, the deteriorated condition of the ceiling necessitated much of its replacement. DPA Architects paid it homage with their colour choices with the ceiling in Resene Half Pearl Lusta, Resene Eighth Pearl Lusta and Resene Triple Pearl Lusta with select details in Resene Lustacryl semi-gloss waterborne enamel tinted to Resene Gum Leaf.

DPA Architects also found the lath and plaster ceiling to be in particularly poor condition due to ongoing water damage from leaks in the roof above. While their original intention was to retain Carter’s mural within the oval, the deteriorated condition of the ceiling necessitated much of its replacement.

“Lath and plaster ceilings are traditionally formed by laying wet plaster over timber laths that are left with gaps between them,” says Dave. “The plaster is applied over the laths with sufficient force to push some plaster in between them, so the laths then act as a key to stop the plaster from falling. In the case of the opera house, the plaster had cracked, the keys were weakened and broken and significant fabric was at risk of damage.

A plaster ceiling can be up to 20mm thick and weigh anything up to 53 kilograms per square metre, so an area of falling plaster has the potential to cause injury – or worse.”

The decision was made to partially replace the plaster and return the auditorium ceiling to an earlier, lighter colour scheme. While retaining what they could of Carter’s mural, the new hues were interwoven in a way that harnessed and complemented the established aesthetic values of the space.

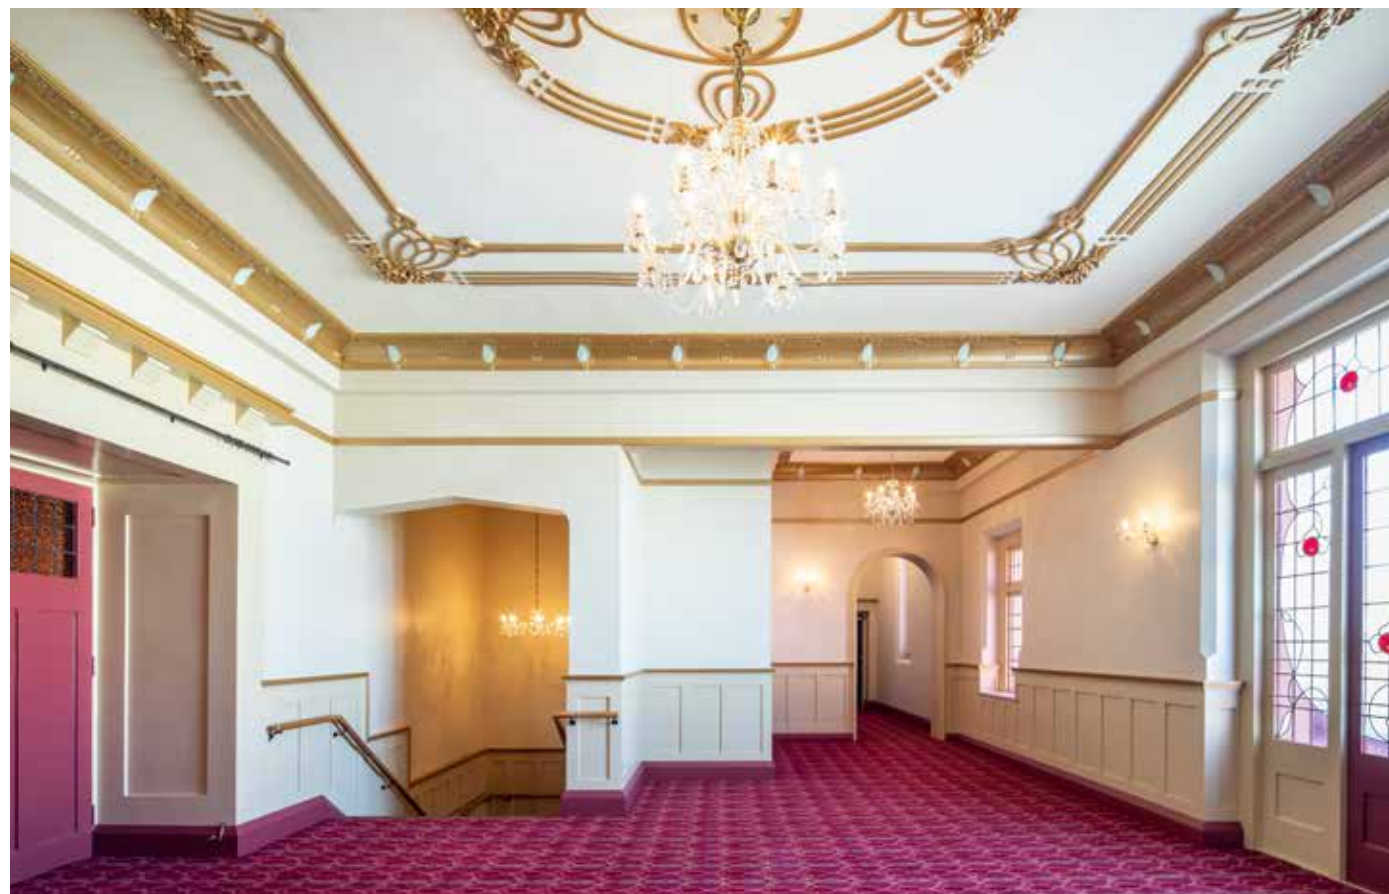
below: Notes of a half strength of Resene Gum Leaf dotted amongst the gold plasterwork in the foyer provide a prelude to the adjoining auditorium. Walls in Resene SpaceCote Low Sheen waterborne enamel tinted to Resene Quarter Canterbury Clay, dados in Resene Lustacryl semi-gloss waterborne enamel tinted to Resene Canterbury Clay, doors in Resene Lustacryl tinted to Resene Merlot and ceiling in Resene Eighth Pearl Lusta.

Vanquish and Resene Merlot, were applied to the walls and doors of the auditorium which, combined with the plush red seating, created an atmosphere of depth and luxury – traditional staples of theatre design. By contrast, the foyers were transformed from formerly dark and seemingly cloistered spaces with a lighter palette of creams and neutral tones, including Resene Canterbury Clay and Resene Eighth Pearl Lusta while the first-floor foyer was anchored with carpets in rich reds and finished with lavish gold plasterwork, including notes of Resene Gum Leaf that provide a prelude to the adjoining auditorium.

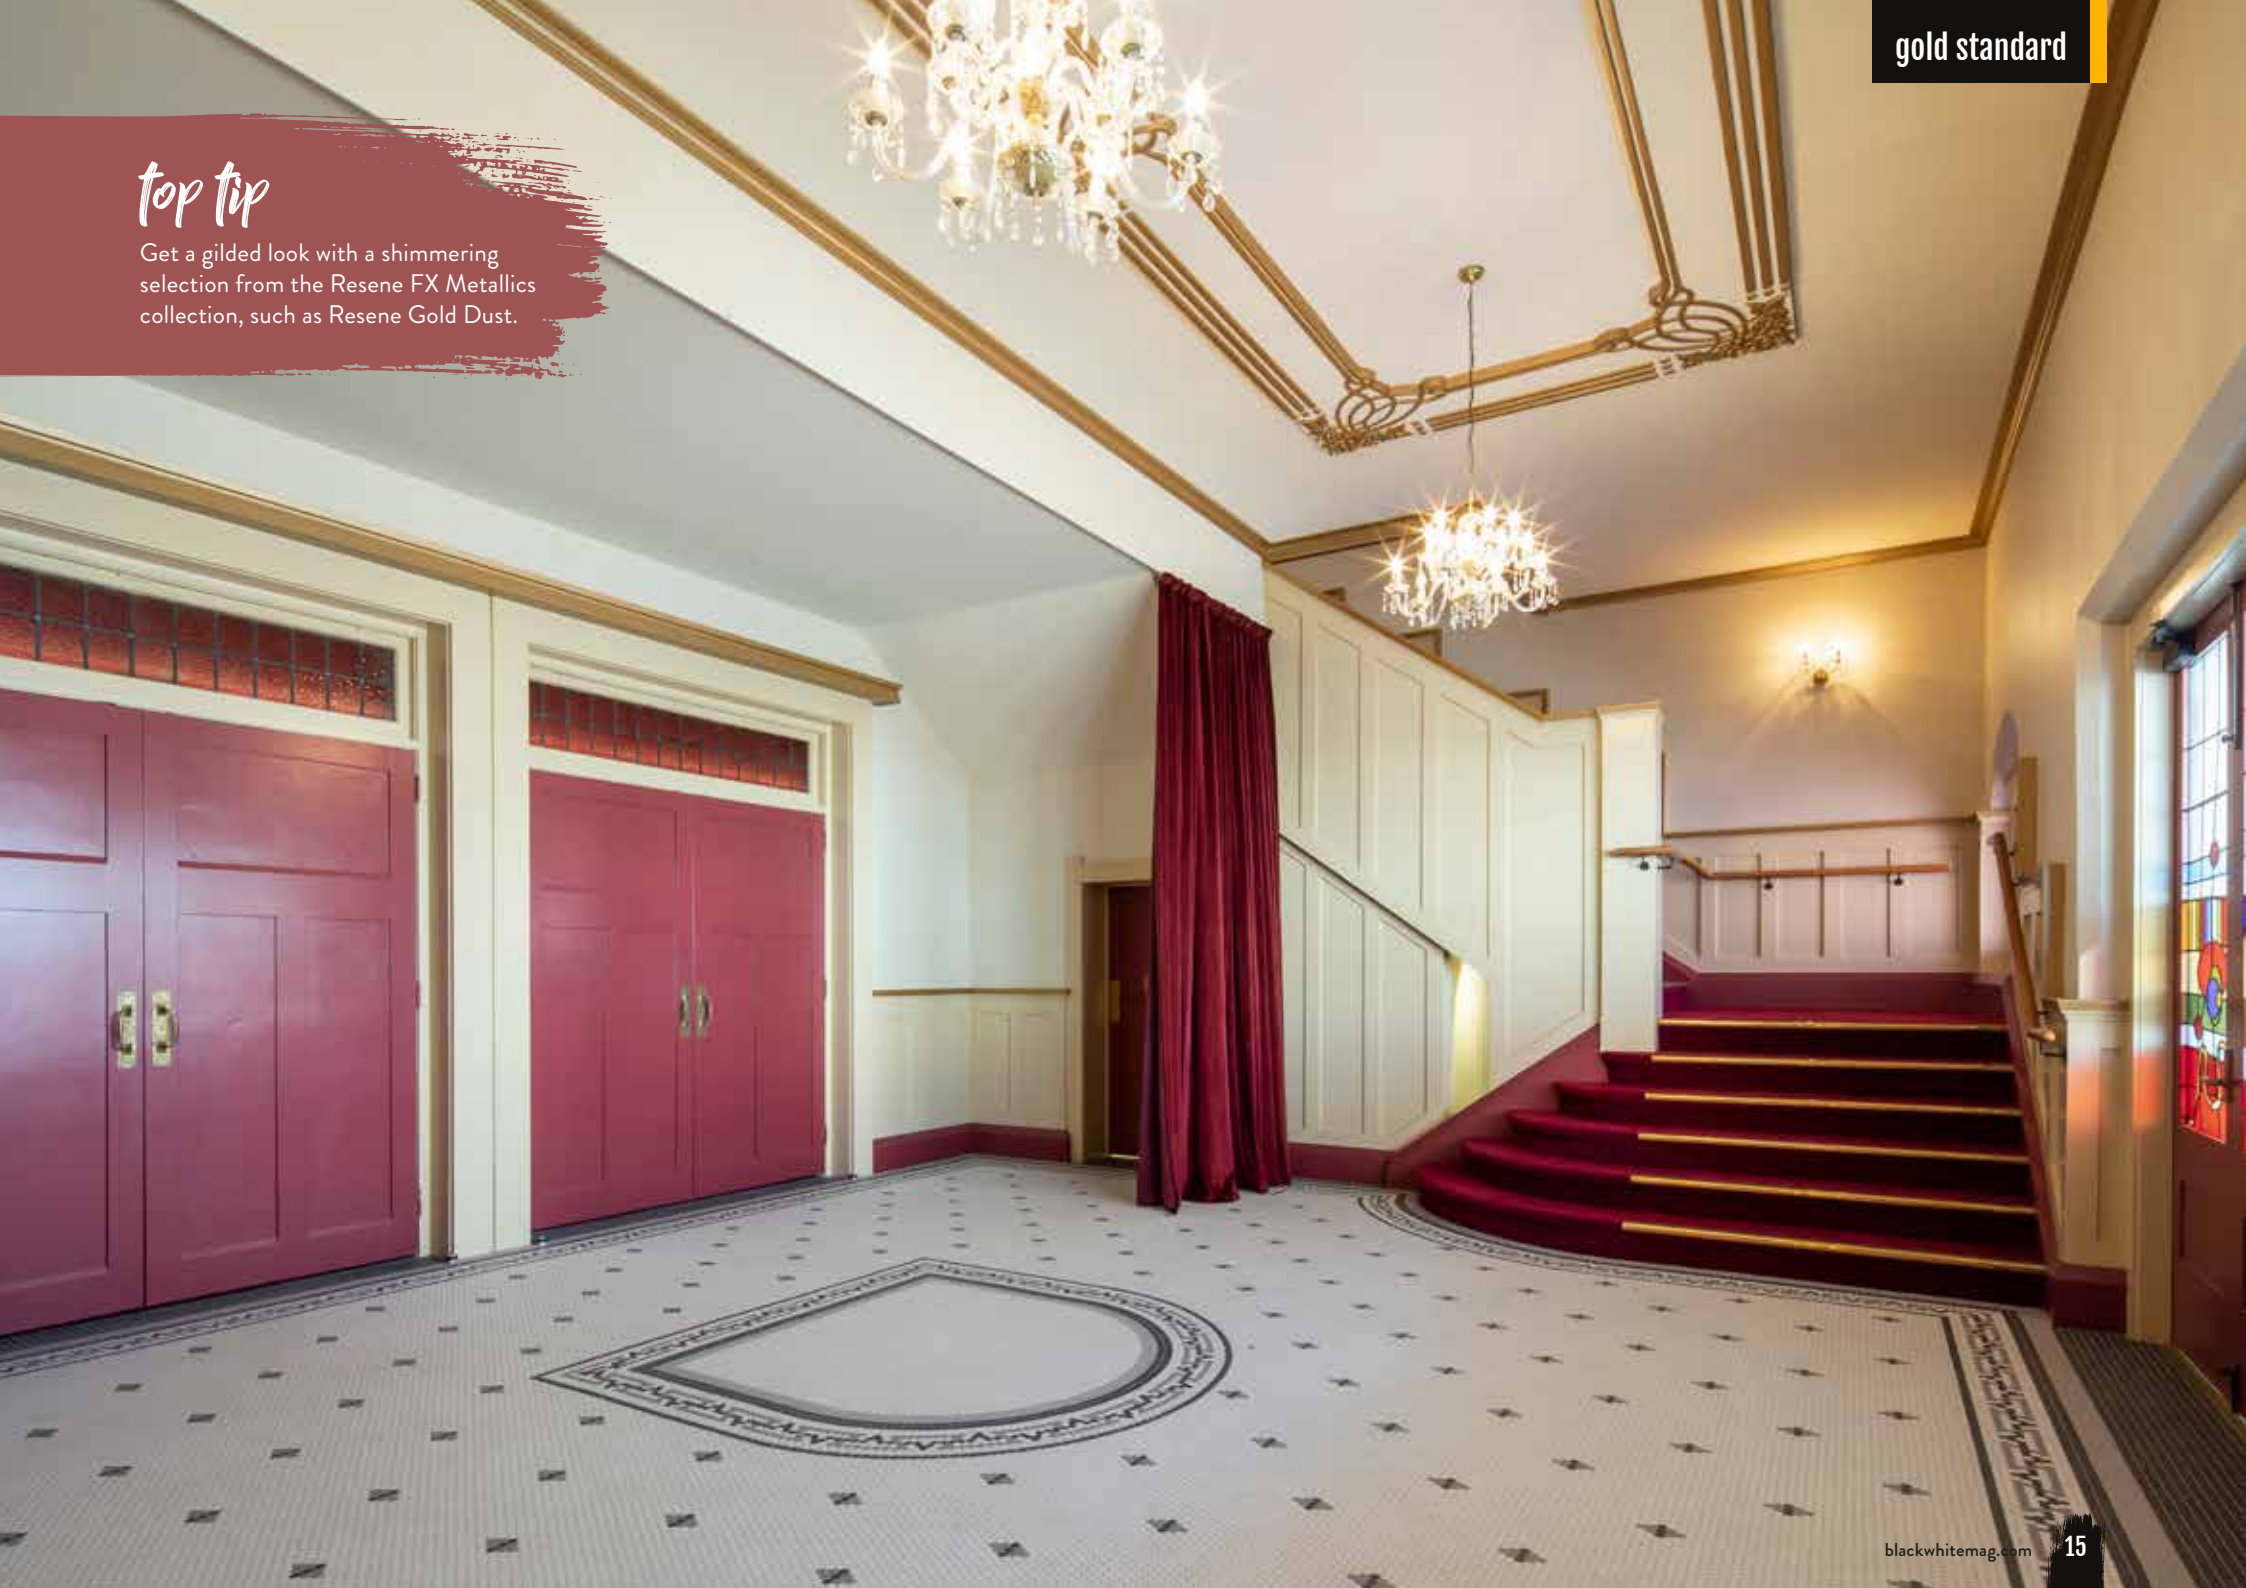
opposite: After careful measuring, mapping and photographing, the replica mosaic tile floor in the entrance foyer looks just as beautiful as the original. Walls in Resene SpaceCote Low Sheen waterborne enamel tinted to Resene Quarter Canterbury Clay, dados in Resene Lustacryl semi-gloss waterborne enamel tinted to Resene Canterbury Clay, doors in Resene Lustacryl tinted to Resene Merlot and ceiling in Resene Eighth Pearl Lusta.

He singles out the mosaic tile floor in the main foyer as his favourite element of the finished project. “We had to rip out all the foundations and flooring and build new, but you wouldn’t have wanted to lose what was there. We measured and photographed it then had the tiles replicated and made new, and that came up beautifully. Of course, the whole building came up beautifully, but that floor looks spectacular.”

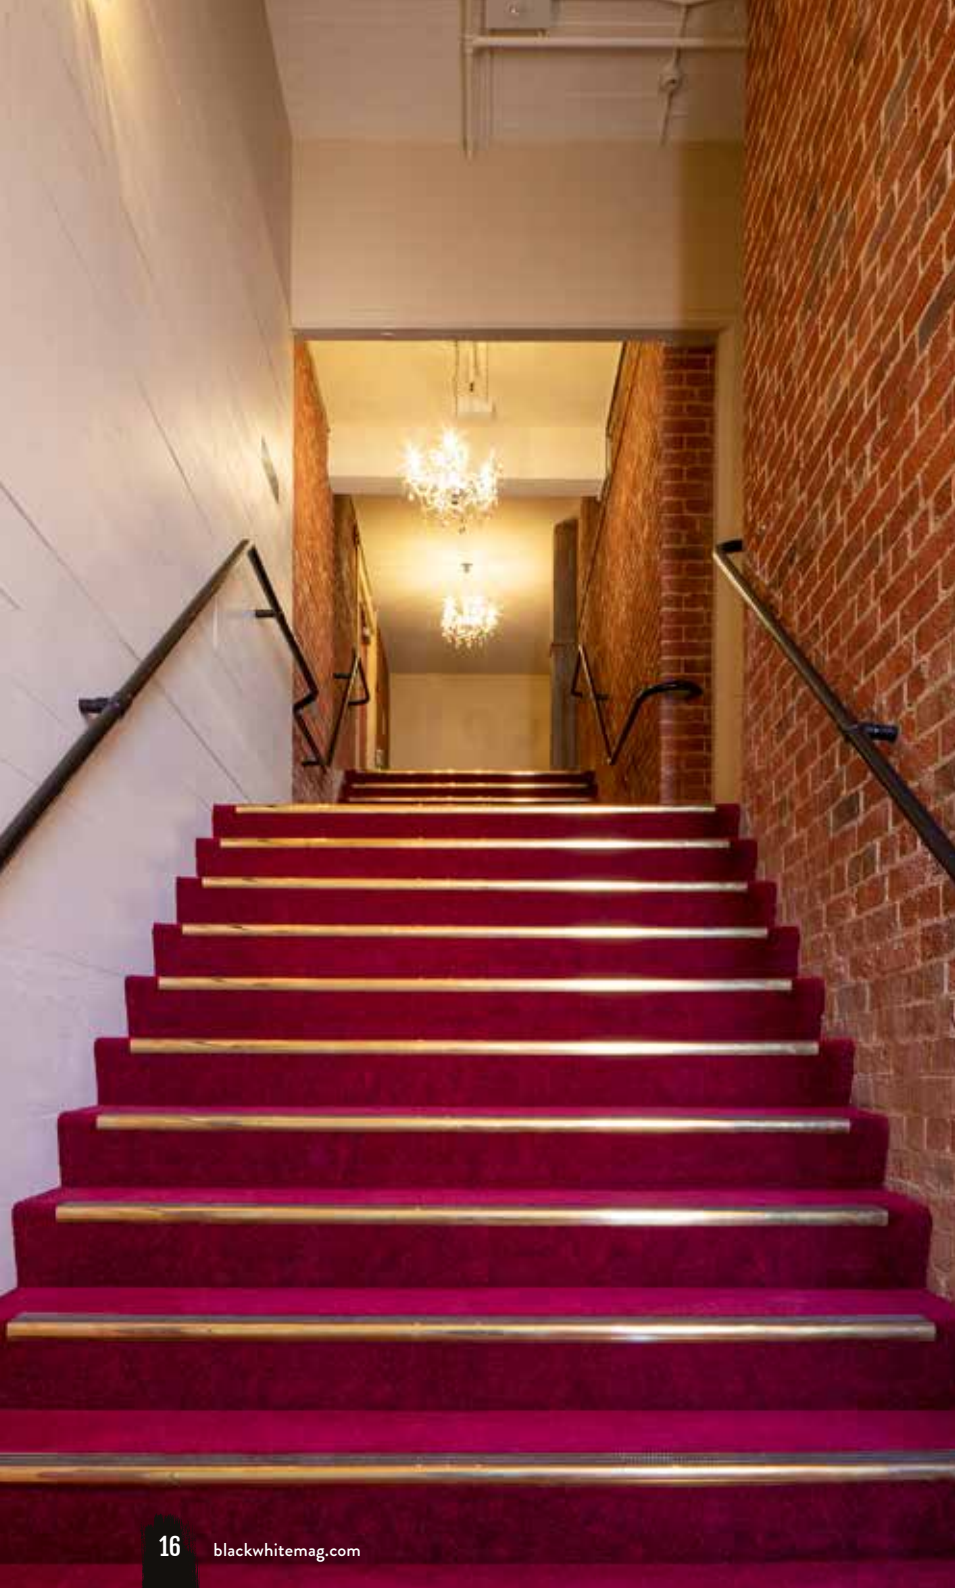
left: The new concrete shear walls were left in their off-form state within the stairwells to match the historic methods of construction. Left wall in Resene Lustacryl semi-gloss waterborne enamel tinted to Resene Quarter Canterbury Clay, ceiling in Resene Eighth Pearl Lusta and bulkhead walls in Resene SpaceCote Low Sheen waterborne enamel tinted to Resene Canterbury Clay.

Looking at the opera house in all her splendour today, it’s hard to tell just how much remediation has occurred – though there are some subtle hints. Newly inserted steel bracing to the staircase above the toilets on the western side has been left exposed, contrasting against sections of Resene Alabaster and offering a glimpse into the degree of intervention that has taken place. Other details, like the concrete shear walls were left in their off-form state within circulation spaces like stairwells, displaying the textures of the boards in which they were formed to match the historic methods of construction implemented in the building.

Beyond the cosmetic improvements, other significant challenges involved the structural upgrades and construction of new concrete shear walls and diaphragms throughout. “Strengthening works required substantial sections of significant fabric, such as plaster finishes and timber dado panelling, to be temporarily removed before being carefully restored and refinished to conceal concrete shear walls beneath.”

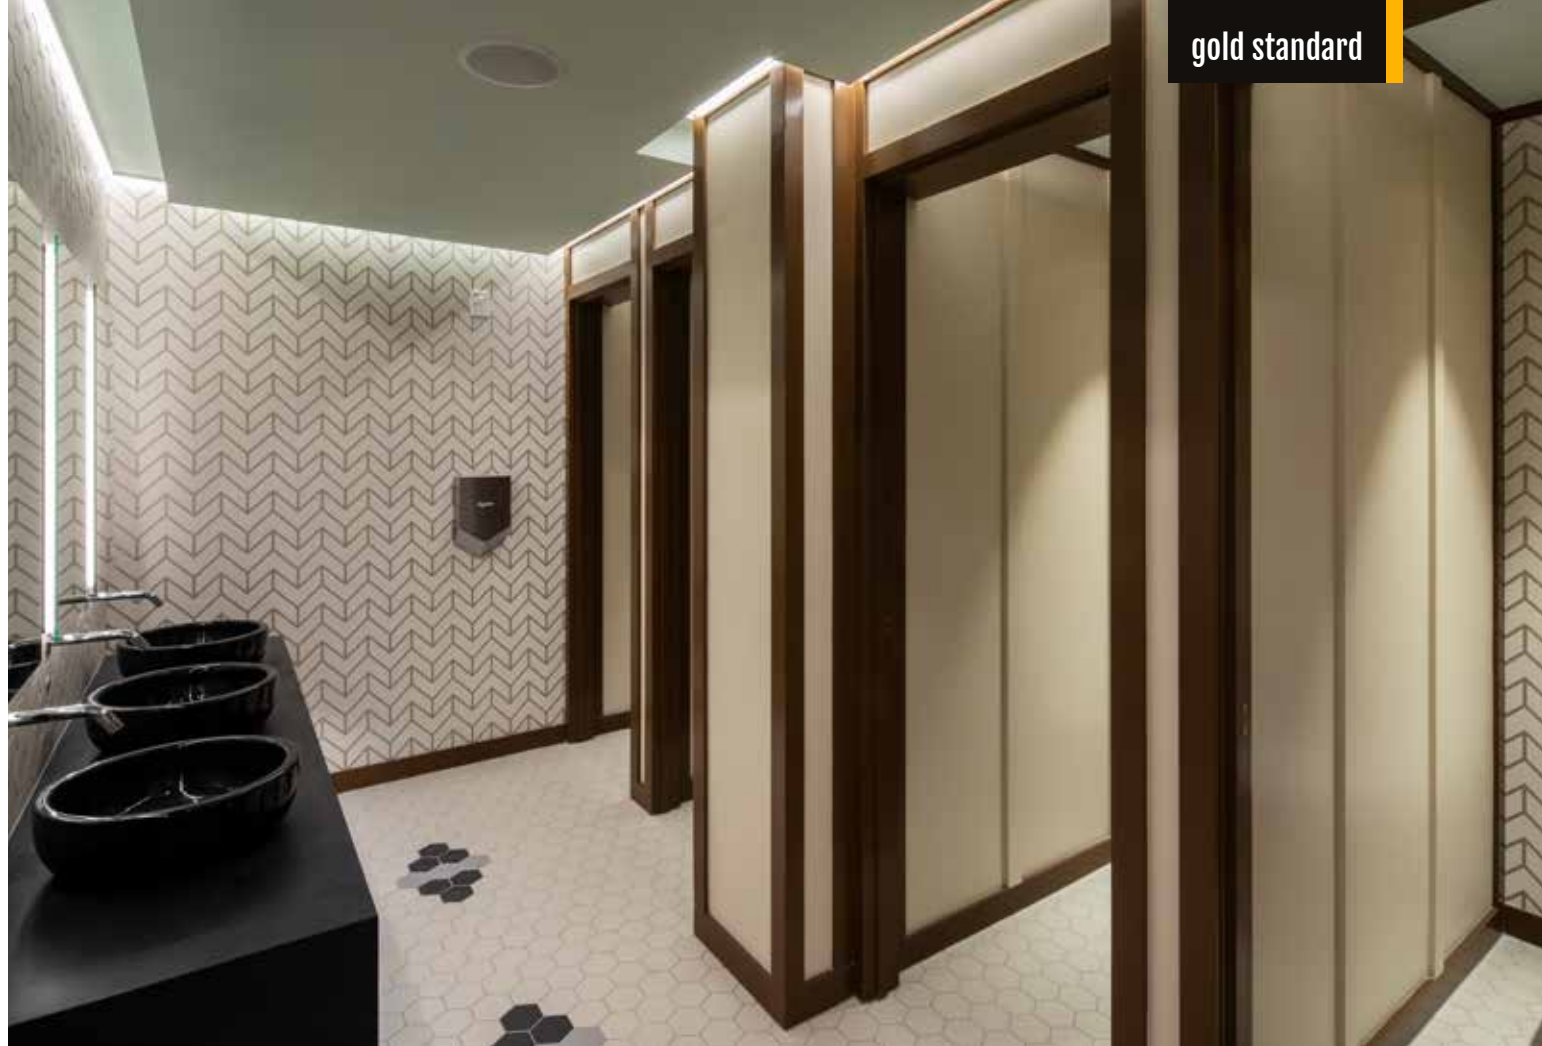
above: While the new toilets certainly boast contemporary comforts and conveniences, the colour palette and details make them feel like an authentic component. Ceiling in Resene Gum Leaf, partitions in Resene SpaceCote Low Sheen waterborne enamel tinted to Resene Quarter Canterbury Clay and trims in Resene Lustacryl semi-gloss waterborne enamel tinted to Resene Carnaby Tan.

A new colour scheme for the toilets, combined with selected wallpaper, bench seating fabric and hexagonal wall tiles, provided a refreshed and contemporary feel with historic overtones. “The toilets were redesigned to include a selection of floorcoverings based on an enlarged version of the original floor tiles from the ground floor entry foyer,” explains Dave. “Rimu skirting was painted in Resene Carnaby Tan from the Resene Heritage colour range, with the finish carried through the doors and timber trims of the cubicles while a half strength of Resene Gum Leaf was used for the ceilings and Resene Quarter Canterbury Clay for the partitioning walls to allow a sense of continuity between the toilets, foyers and auditorium.”
